Manhole Inspection Summary

Manhole # S35M__008MH

Insp Date: **3/24/08 3:07 PM**

Location Address: **12 w. hill**

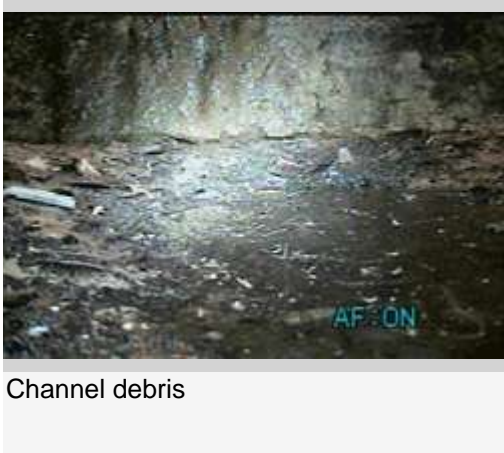
Defect 3

Condition: ☐ Sound ☐ Cracked ☐ Root Intrusion ☐ Deteriorated ☐ Leaks ☒ **Debris**

Channel debris

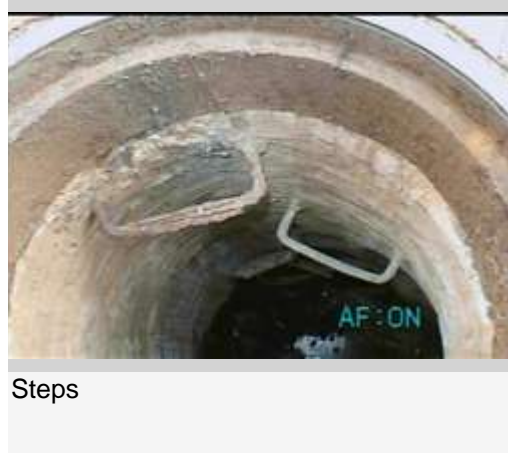
Defect 2

Steps Count: **6** Missing: **0** ☒ **Corroded**

Steps

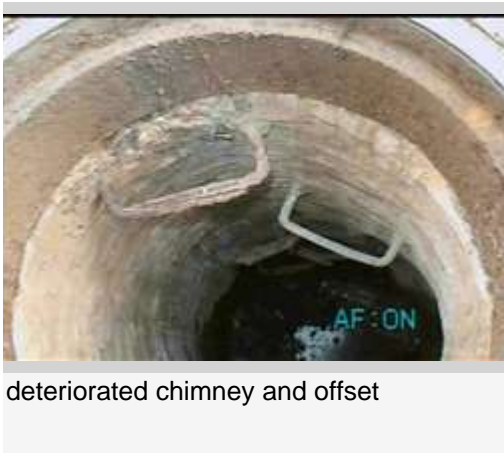
Defect 1

Condition: ☐ Sound ☐ Cracked ☐ Root Intrusion ☐ Loose Brick ☒ **Deteriorated**

deteriorated chimney and offset

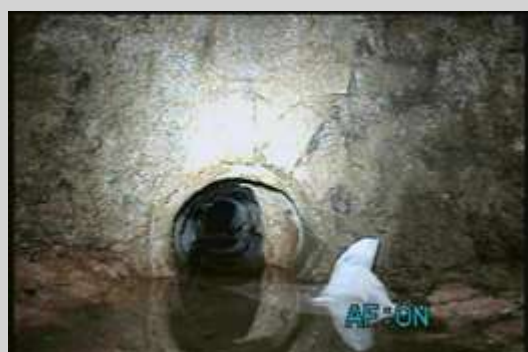
12 O'Clock Outflow

Comments **Standing water in channel**

standing wate in channel

Deposits: ☐ None ☐ Mud ☒ **Gravy** ☐ Debris ☐ Grease

Silt Depth: **3** (in.) Deposits Extent: **Light**
